# Manhole Inspection Summary

Manhole # S23MM\_012MH

**Location** Address: **2447 FRANCIS ST**

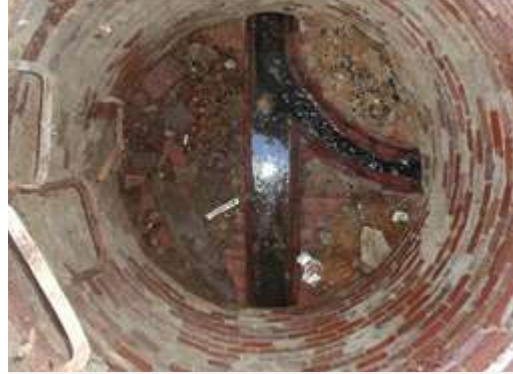
Top View

Corroded steps. Evidence of surcharge - Bench debris. Channel debris.

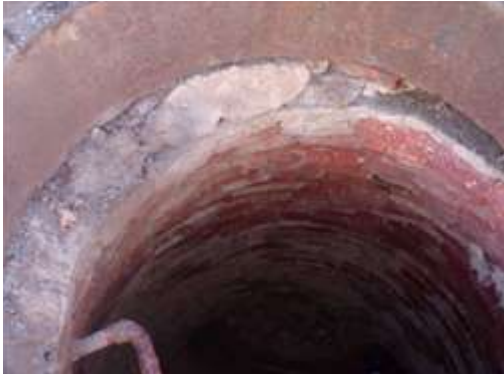
Defect

Frame leaks. Frame offset. Adjustment deterioration and infiltration. Corbel and Barrel infiltration.

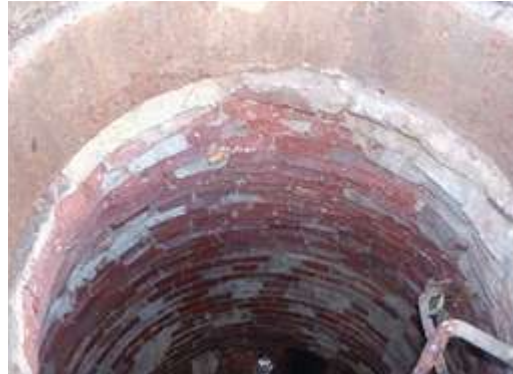
Defect

Frame leaks. Adjustment deterioration and infiltration. Corbel and Barrel infiltration.

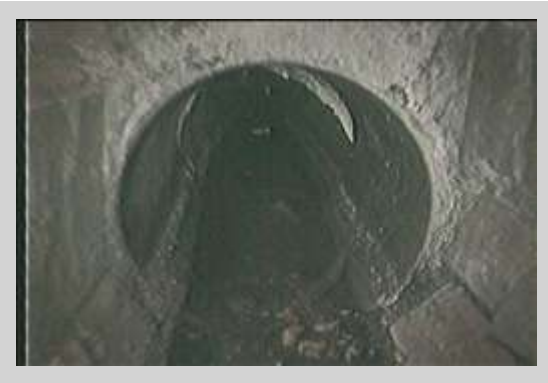
### 8 in. Circular Gravity Sewer Pipe Out @ 12 O'Clock

Channel deterioration.

Deposits: ☐ None ☒ **Mud** ☐ Sludge ☒ **Debris** ☐ Grease

Silt Depth: **0.5** (in.) Deposits Extent: **Light**

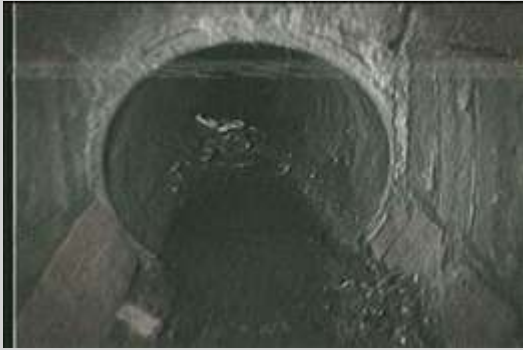
8 in. Circular Gravity Sewer

Deposits: ☐ None ☒ **Mud** ☐ Sludge ☒ **Debris** ☐ Grease

Silt Depth: **0.5** (in.)
